## Acoustic levels of heavy truck tire ruptures

Matthew Wood M.S. \*, William Woodruff Ph.D.

InSciTech Inc., 185 Berry St., Suite 3700, San Francisco, CA 94107, USA

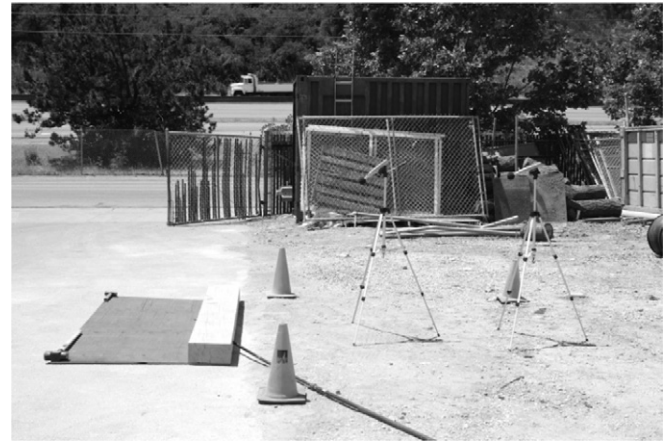
Fig. 2. Overall test setup with roadway mockup, striking object, and sound level meters.

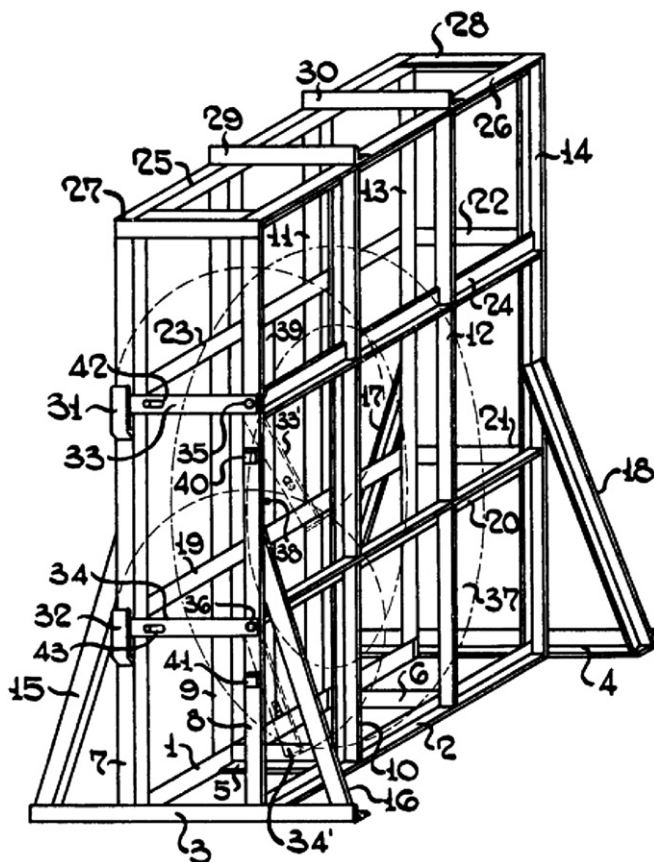
The fact that sudden tire failures occur is known to drivers of heavy vehicles and those within the tire- and tire-servicing industries. The potentially dangerous nature of these events and the chance of catastrophic injury in these non-collision accidents has been recognized for decades as evidenced by the presence of tire inflation cages and guards as early as 1946 (see Fig. 1).

Fig. 1. Tire inflation guard — U.S. Patent 2407049.
